Confirm Job No :- 2046387

Works –Highway Drainage

On site - October 2022

Location :- Chalk Hill, Cockernhoe (Adj. Offley Footpath 007)

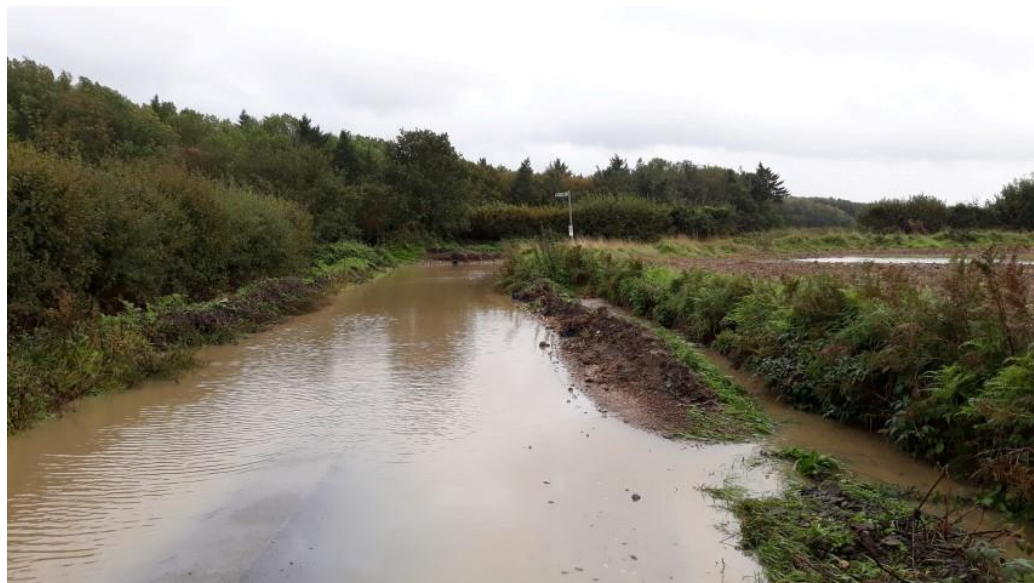
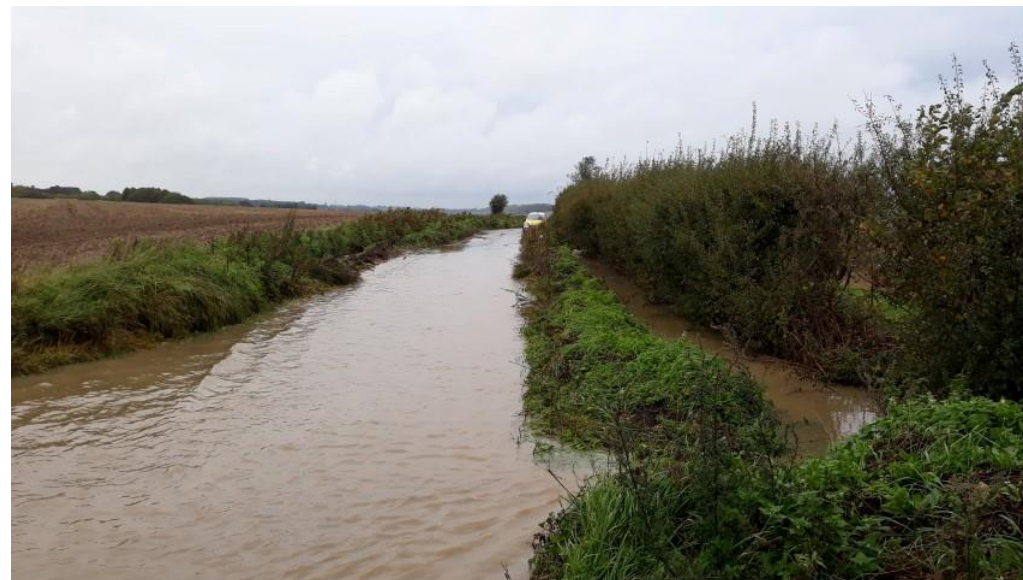
FLOODED BEFORE

ISSUE :- Carriageway permanently holding water (above) , Verge & Ditch line overrun

SOLUTION :- Reinstate Ditch Berm, Install Kerbed & lined Grips incl. Verge markers.

Install 2 No. soakaways with overflows

Silted Ditch regraded & Carriageway sided out throughout.

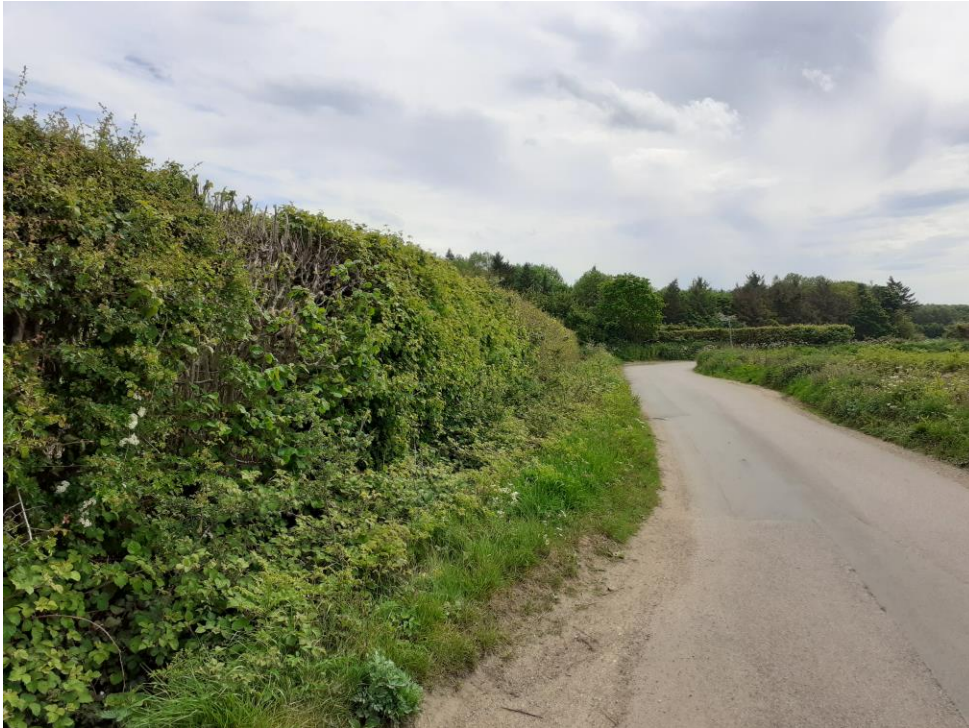
BEFORE

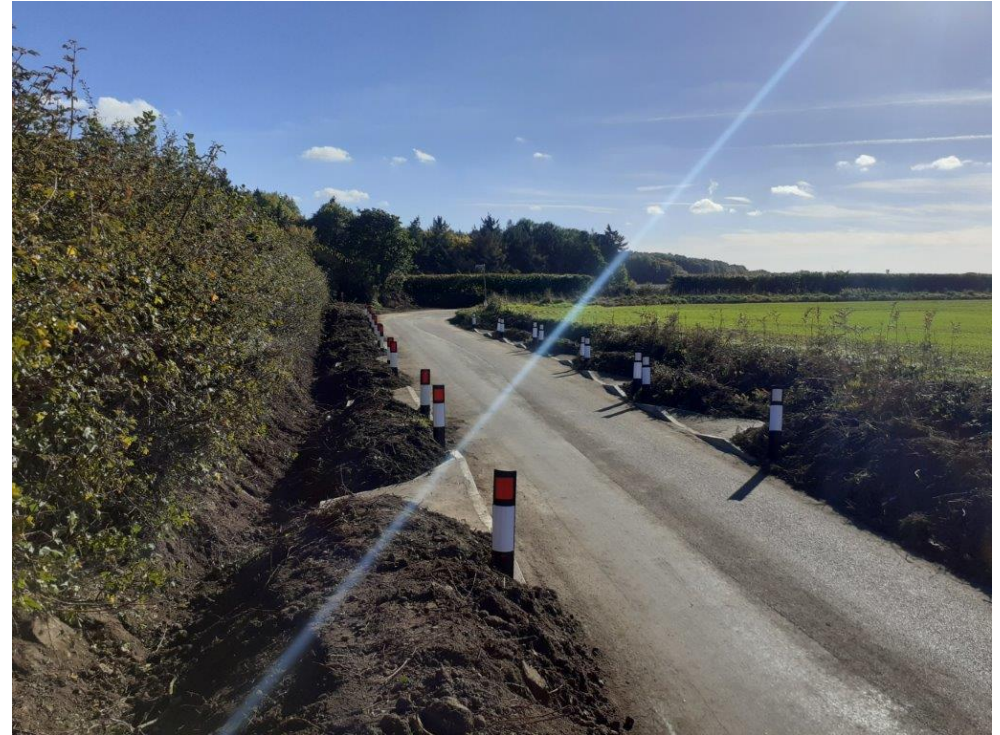
AFTER

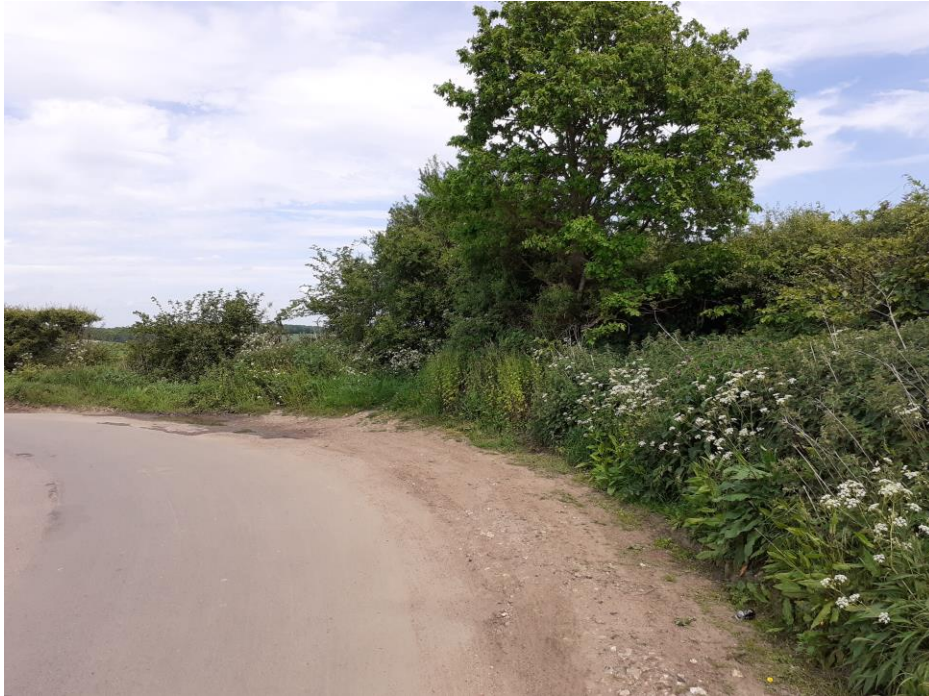
BEFORE

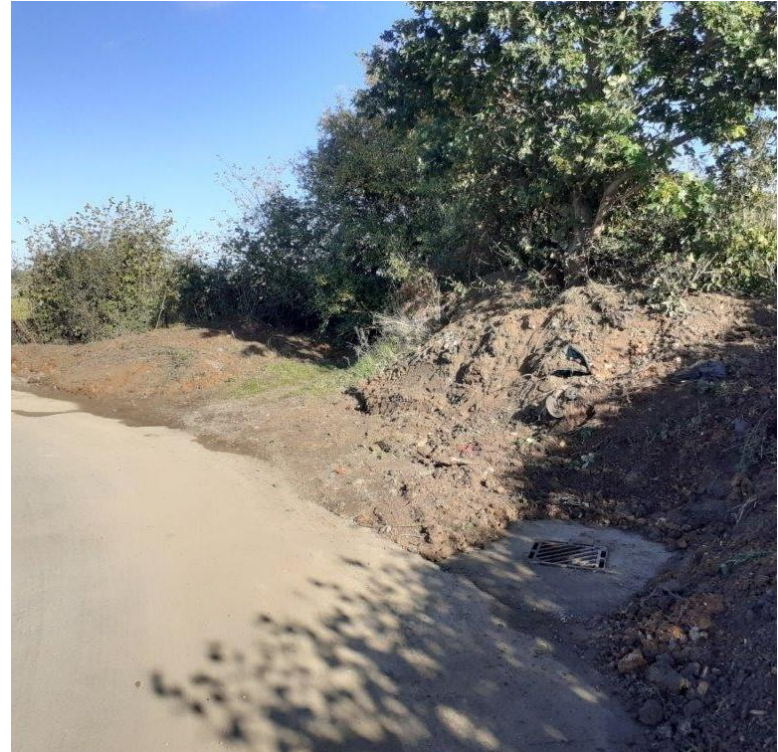
SOAKAWAY INSTALLED

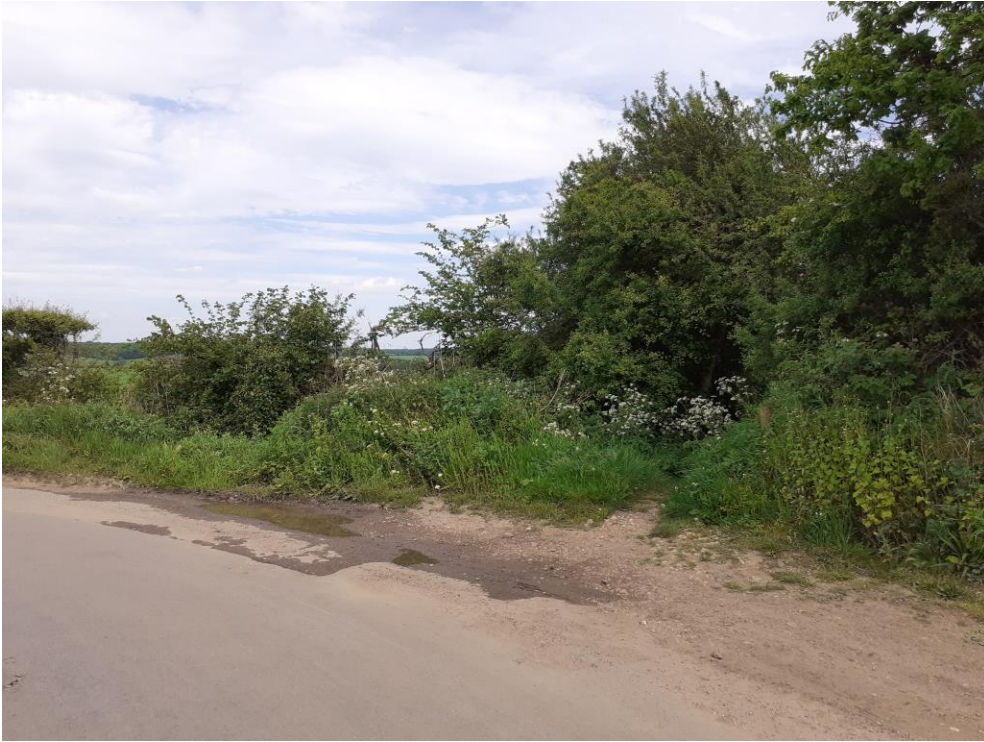
BEFORE

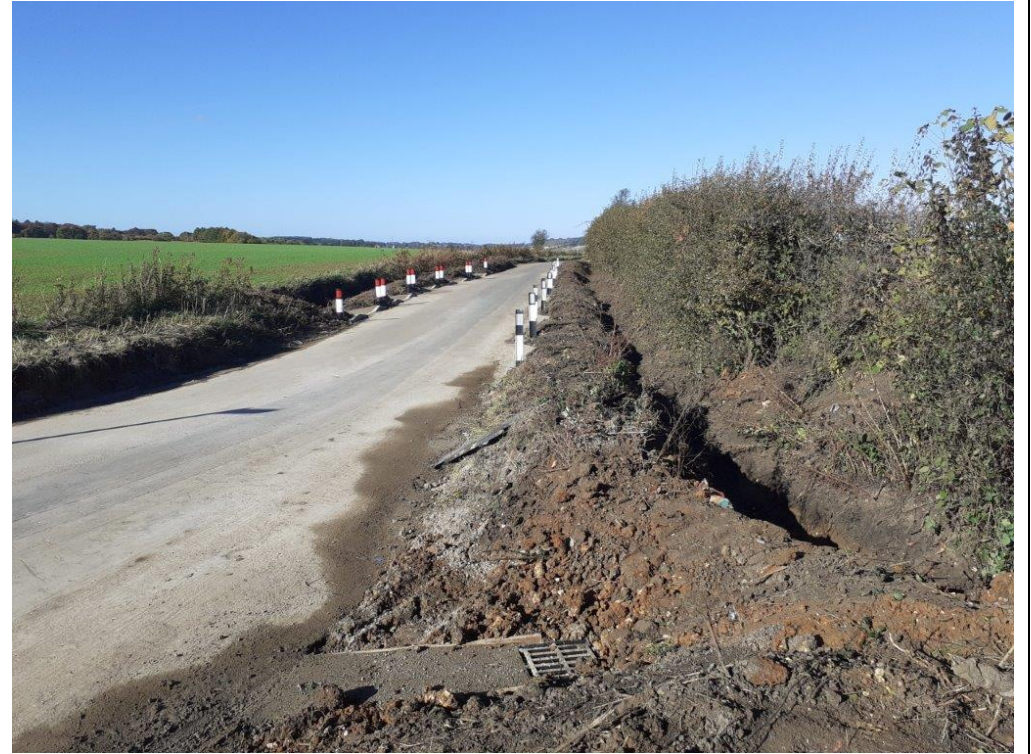
SOAKAWAY INSTALLED & DITCH REGRADE

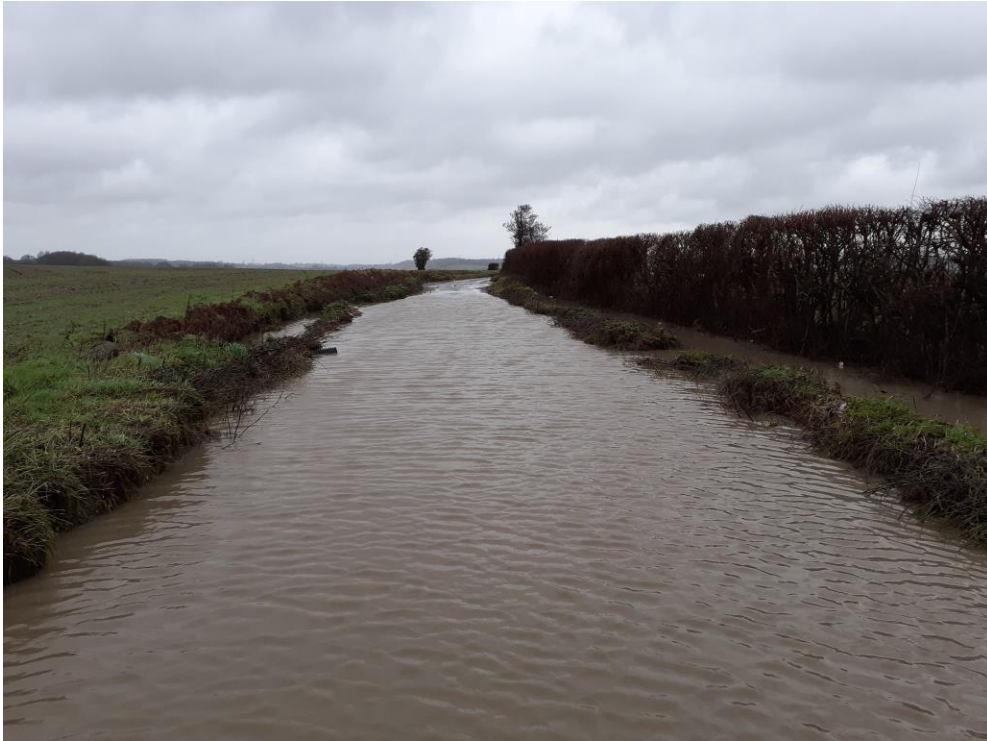
FLOODED BEFORE

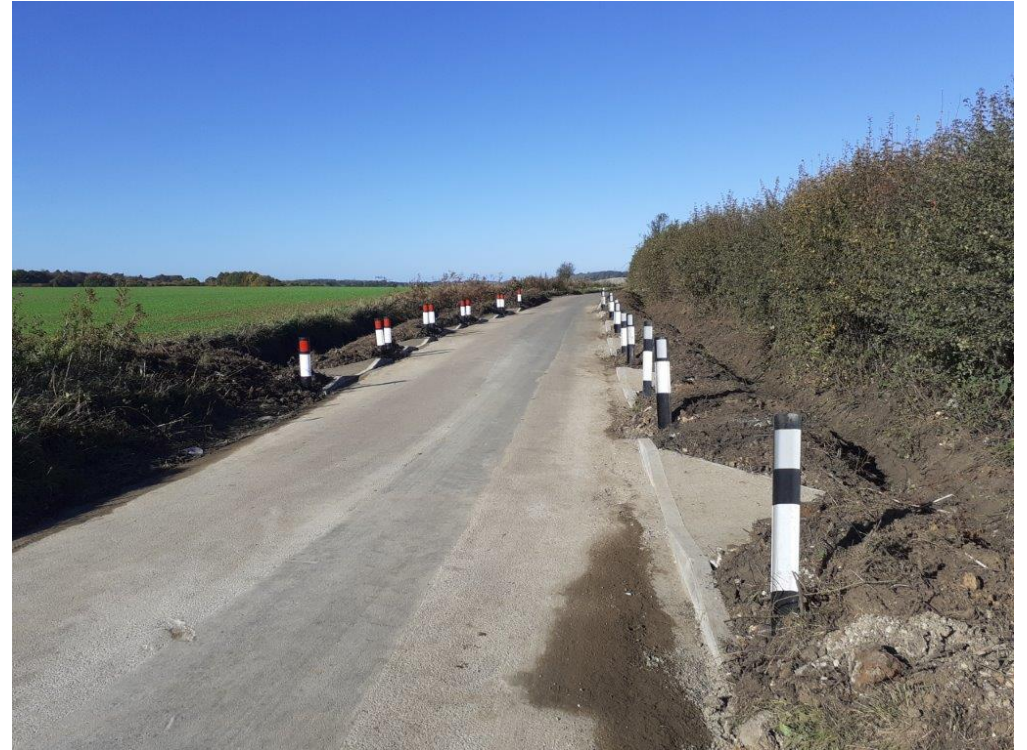
KERBED & CONC. LINED GRIPS INSTALLED (incl. Verge markers)

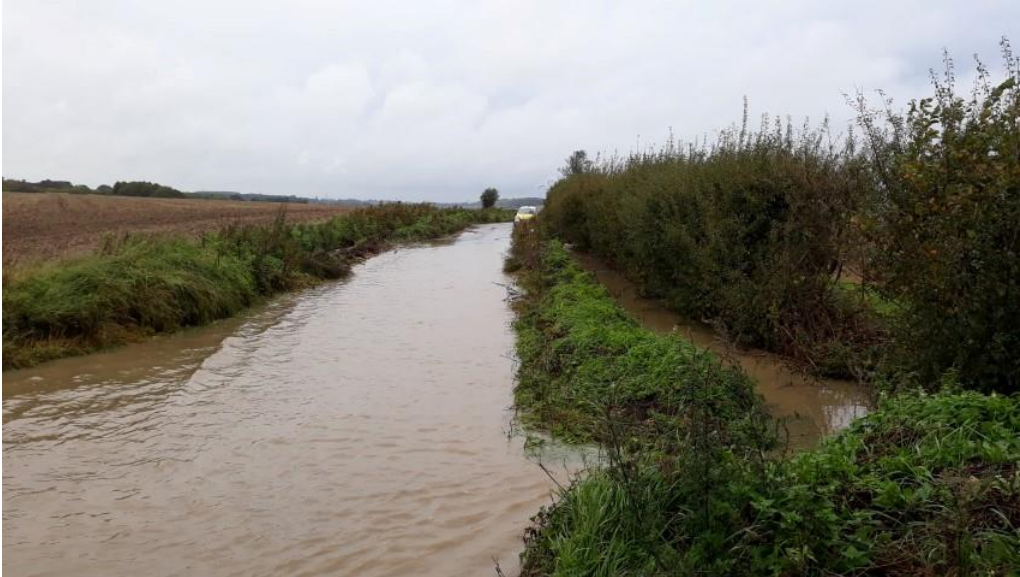
FLOODED BEFORE

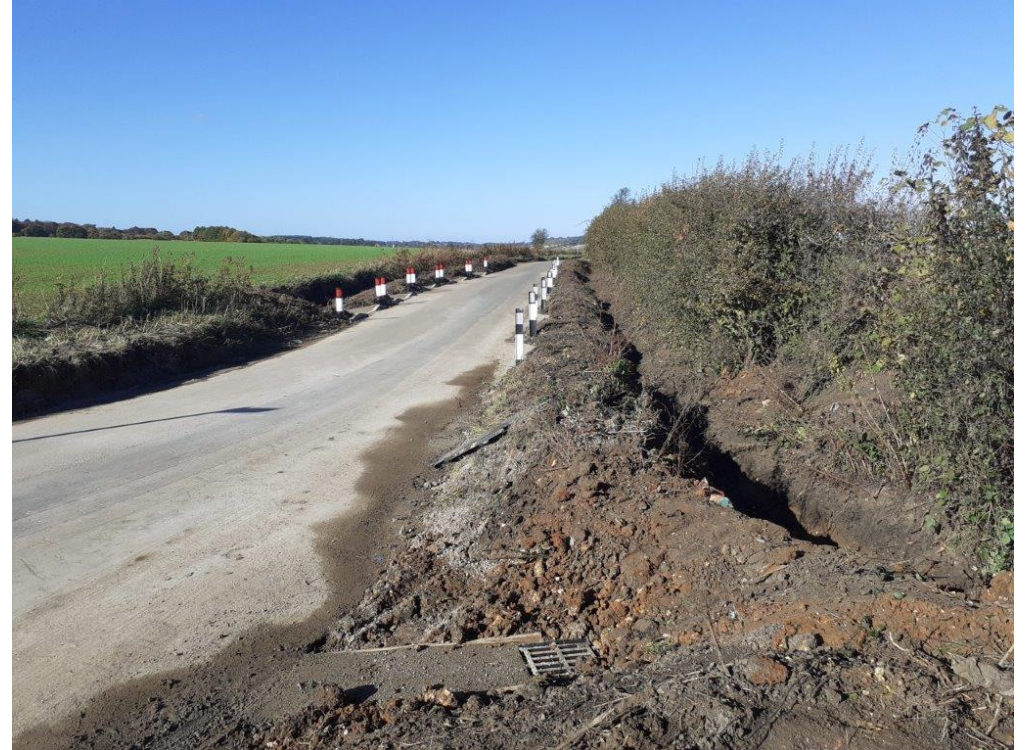
SOAKAWAY, DITCH REGRADE & GRIPS
